OnPoint Home Inspections Service

March 16th 2026, 10:00 am

INSPECTION DESCRIPTION: General Home Inspection plus Air Radon

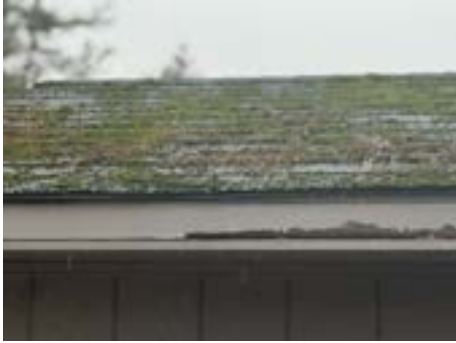
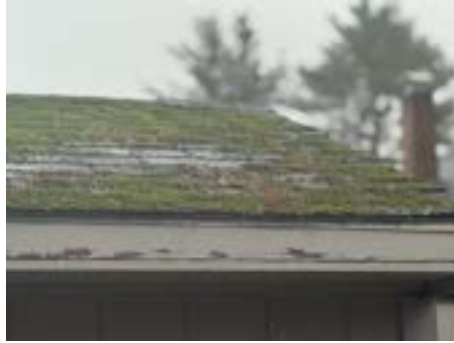
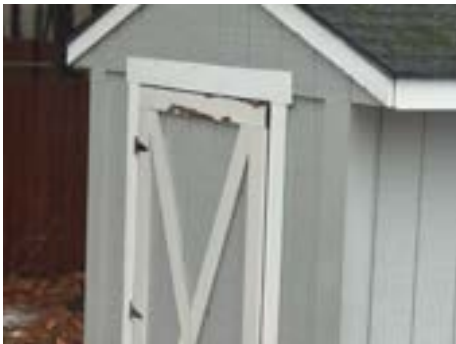
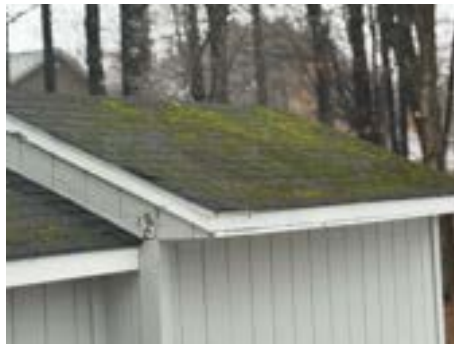
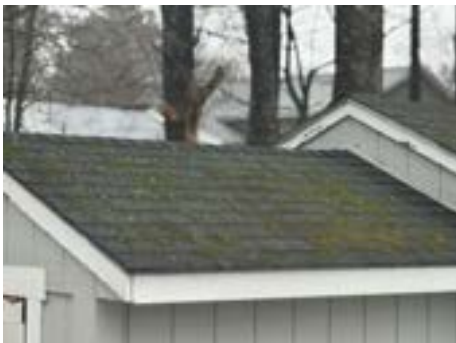
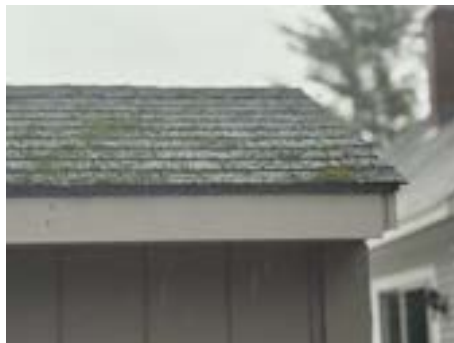
The roof just needs a chemical /water mix that you spray and applicate, let it sit and then rinse thoroughly. The door trim was a bit punchy. I recommend replacing the door trim.

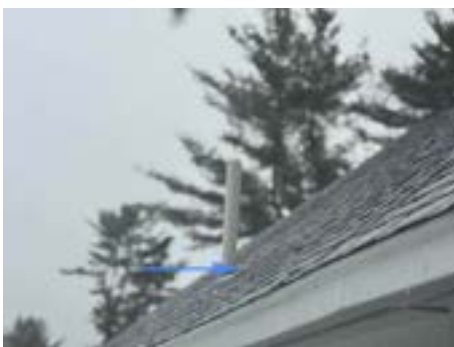
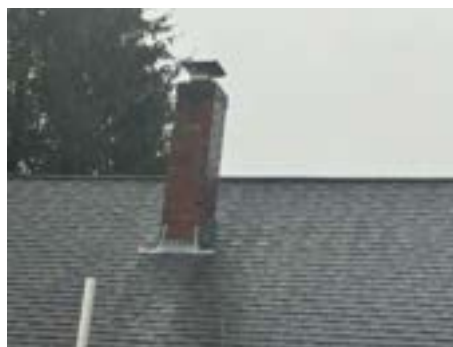
The chimney and the plumbing pipe (stink pipe) were in good condition.

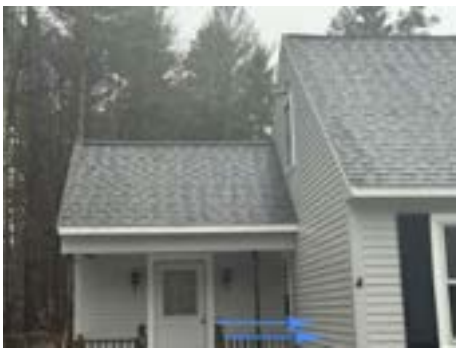
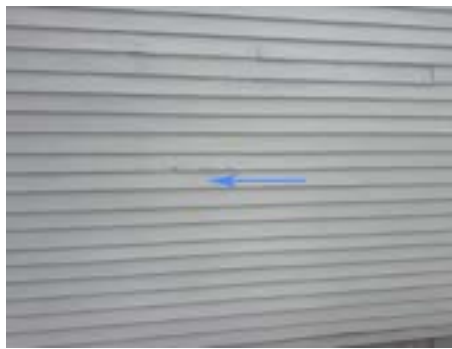
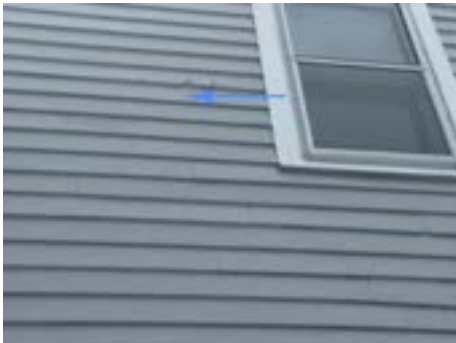
There was some siding on the driveway side that was punchy and should be replaced. There was a couple panels at the far end of the home that had some yellow residual on them coming out of the pores of the clapboard. I recommend replacing those as well.

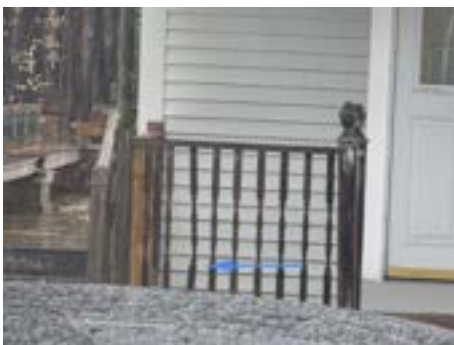
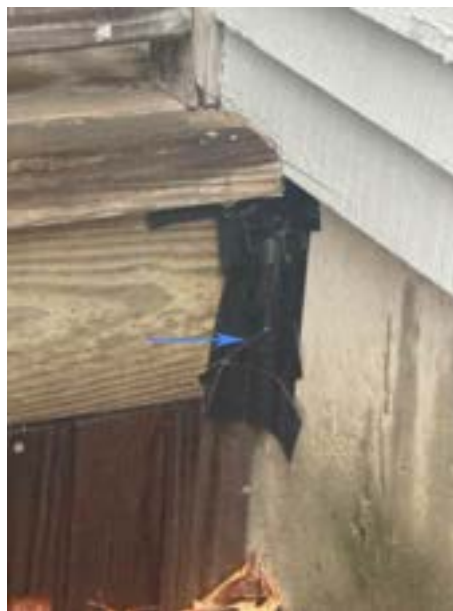
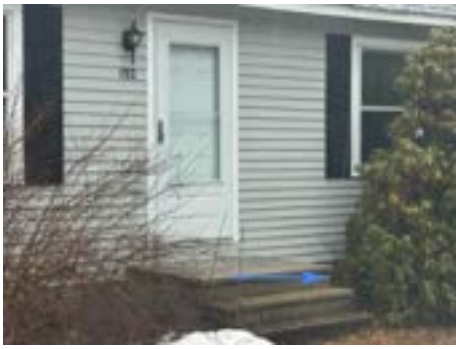
I recommend replacing the spindle on the driveway porch, remove the tape and make the necessary repairs to prevent any penetration. I suggest install railings and balusters on the front steps.

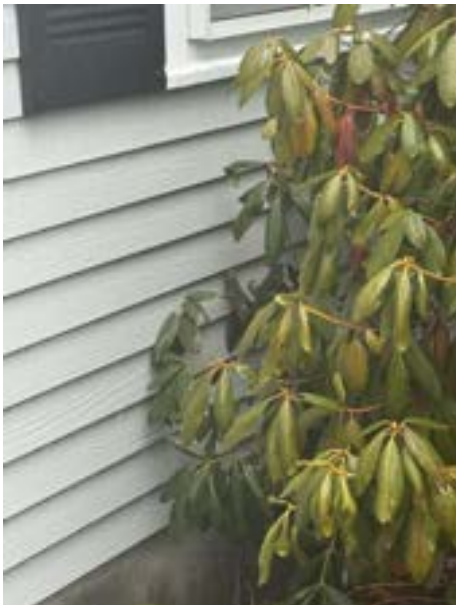
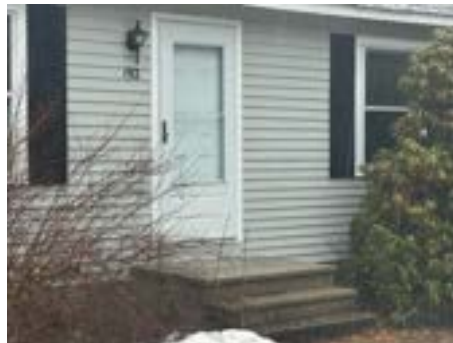
I recommend cutting these two bushes in the front yard back away from the house so it doesn't accumulate snow and allow it to melt and infiltrate the window sills.

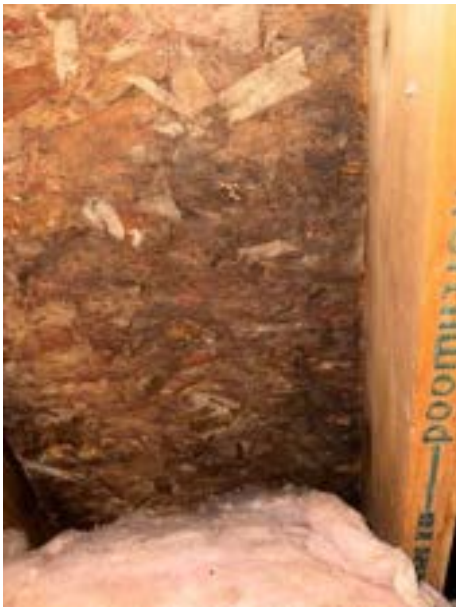
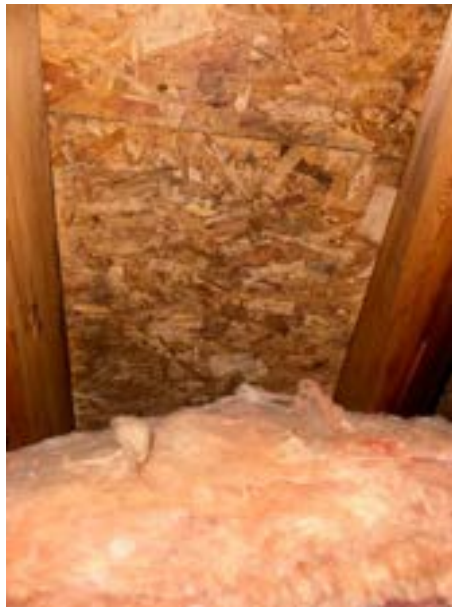
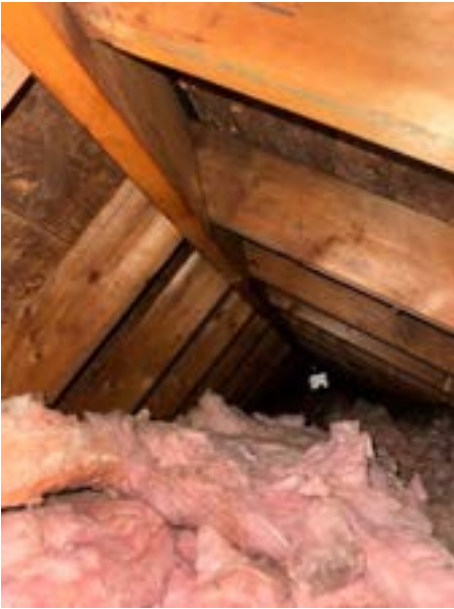
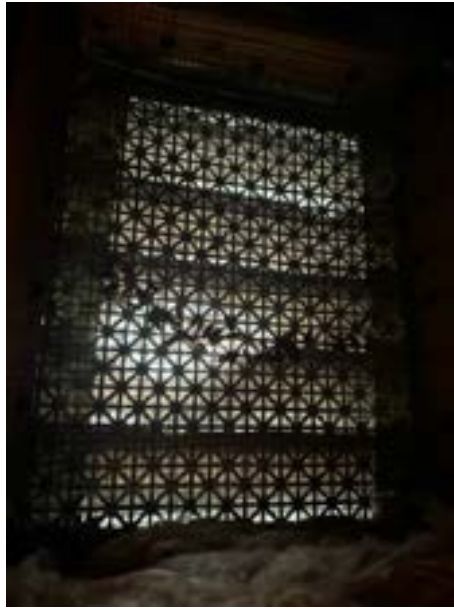
There should be better ventilation in the small space. The blackening of the sheathing suggests it was holding moisture. I recommend cleaning out the screens that are holding the bug infestation.

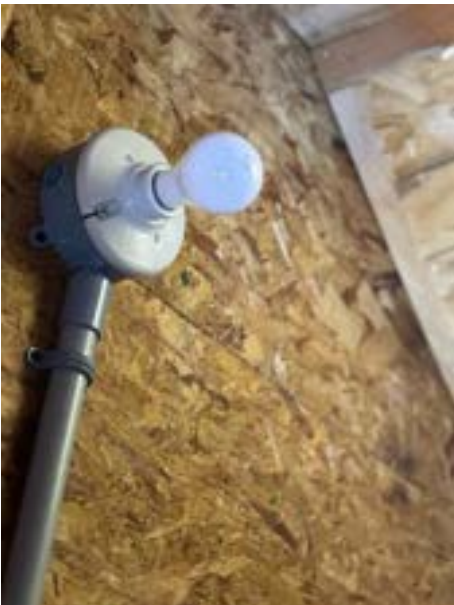
The attic access is not accessible for the average human. I recommend installing a retractable set of stairs in the small common area hallway for easier access. The current was too narrow of an opening. Replace the non-performing light bulb in the breezeway attic access panel.

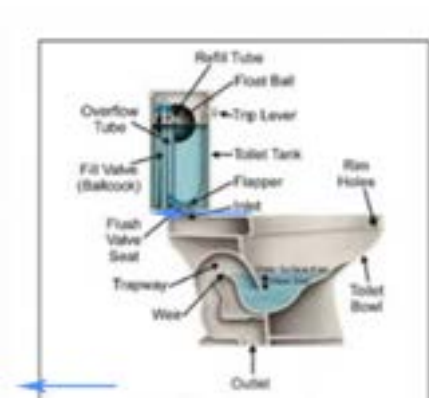
The toilet has some leaking when it was flushed. I recommended the fill valve fasteners get fastened down tightly. Please do not overtighten. And next to be safe, I suggest replacing the water line from the wall to the fill valve.

Note: The bathroom is a bit small. I recommend either of some type of dormer or possibly a rear full dormer in the rear to expand that bathroom and do a second full bathroom. I'm not positively sure at 6' 3", I could actually shut the door while trying to go to the bathroom and as soon as everyone walks up the stairs, they would be seeing me inside the bathroom.

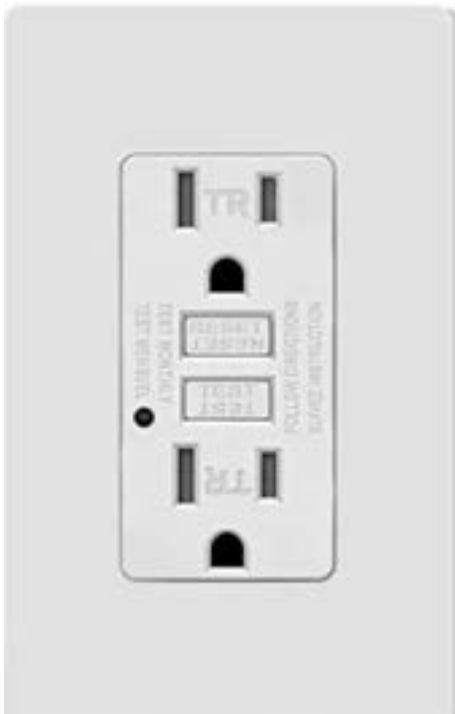
It was an outdated ground fault circuit interrupter, but it tested out correctly. I recommend if you are updating any type of electrical, I suggest replacing the current gfci (ground fault circuit interrupter) for added peace of mind.

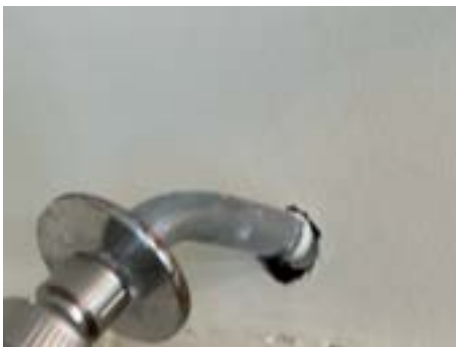
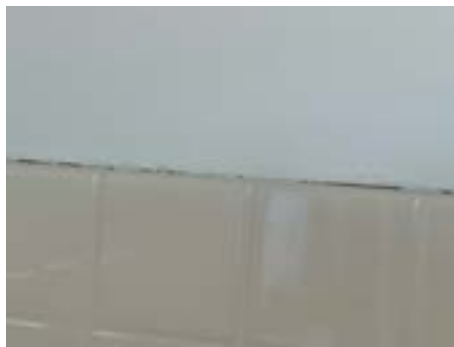
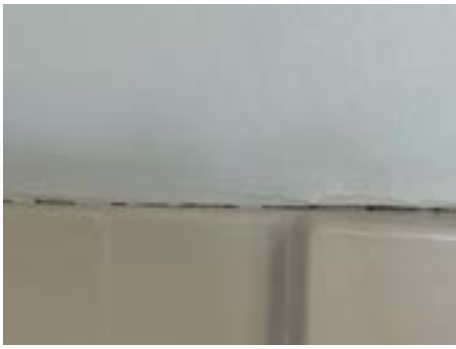
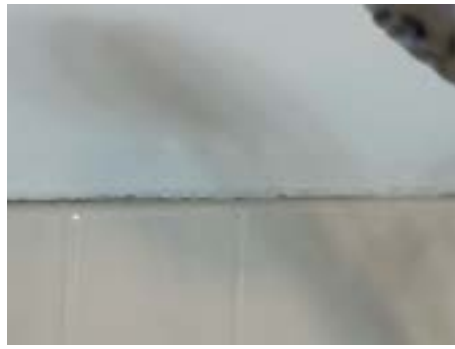
The bathtub/ shower had good water pressure. The warm water was warm to the touch. The tub held water and drained without hassle. I recommend re caulking the top of the shower/tub stall periodically. It keeps water from entering behind the walls. The cover over the shower head should be covering the hole that expose the interior wall.

Note: I recommend using that closet in the room behind to create a hinged access panel with a handle behind the shower/tub for repairs.

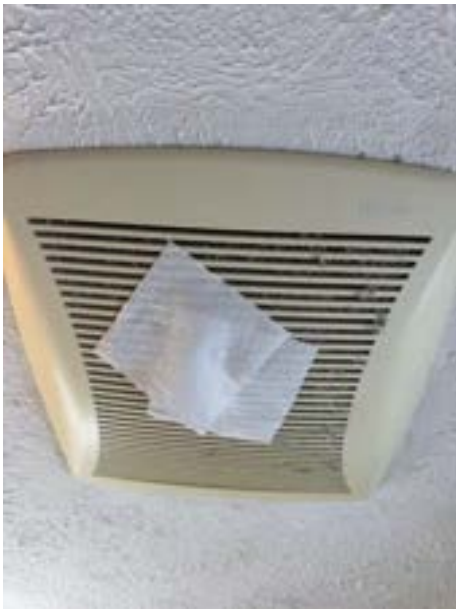
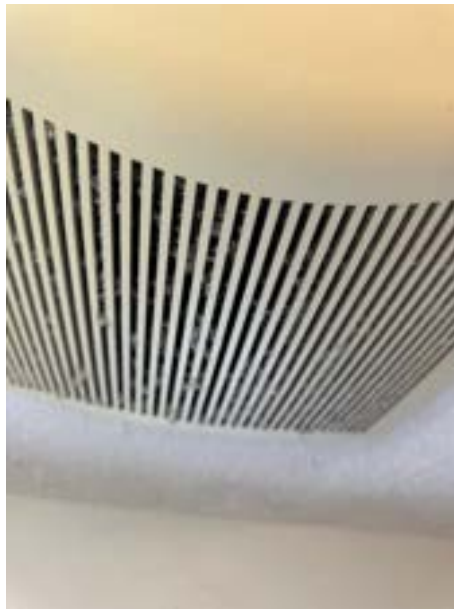
I recommend vacuuming out the ceiling vent in the downstairs bathroom as it has accumulated a lot of lint. It will improve its performance on removing condensation from the bathroom space.

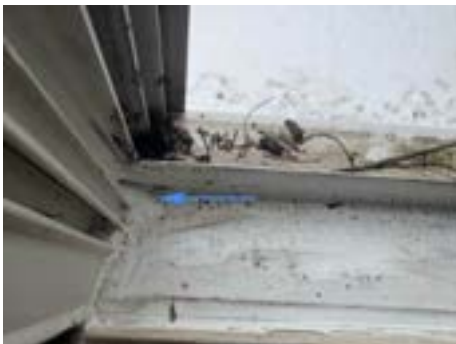
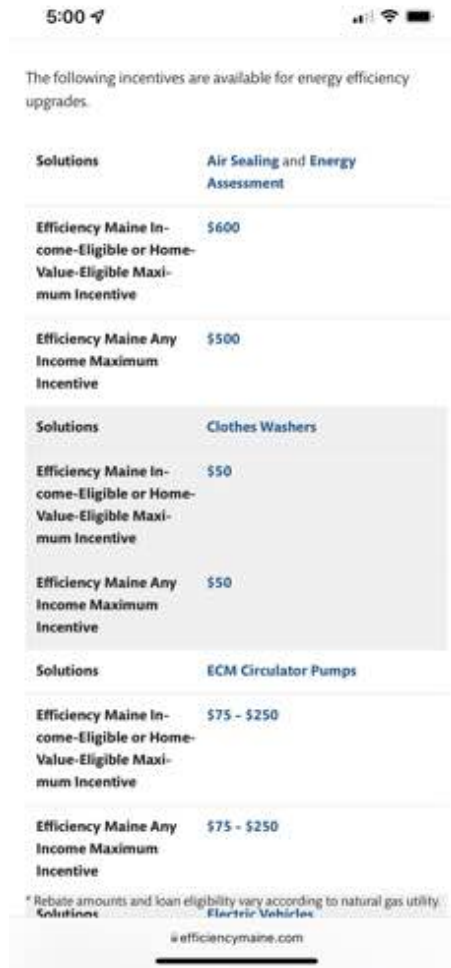
The window sill was corroded as I could see my finger exposed from the outside of the window. I recommend the window gets replaced with a new vinyl replacement. Refer to Efficiency Maine to receive instant rebates on high efficiency components of a home.

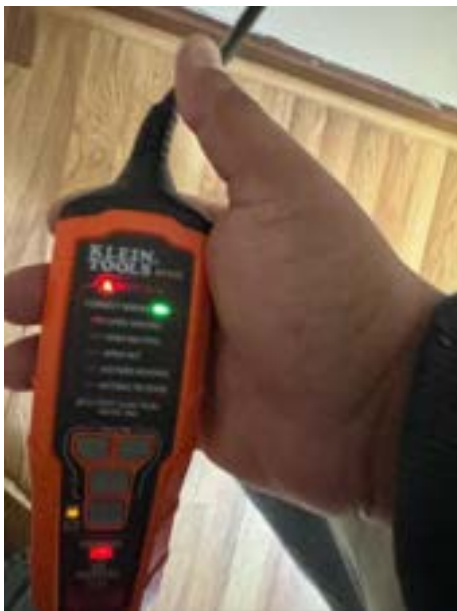
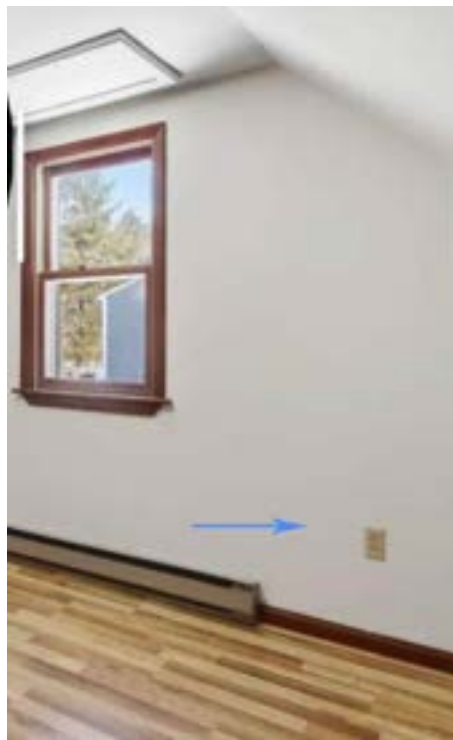
There was a receptacle to the right of the window that would not allow my outlet tester to plug in. I believe there was a ground prong broken off in the prong. I recommend that broken prong gets removed immediately for added safety.

I recommend just pulling out that grounded that broken ground that was in the room upstairs that has to the right of the window and it's the top receptacle.

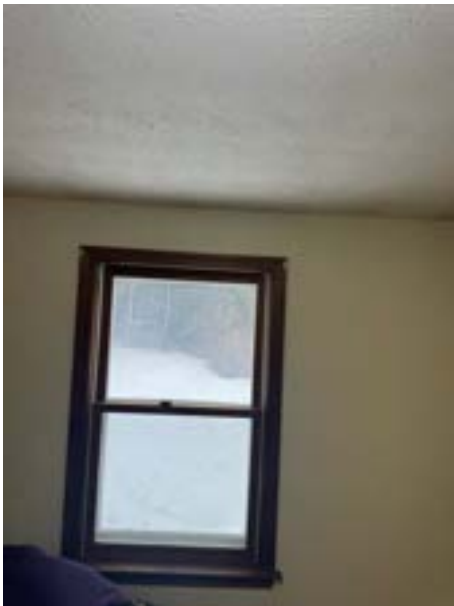
The window should be cleaned thoroughly on the inside and outside. If the film doesn't go away, the bedroom 3 window will need replacement.

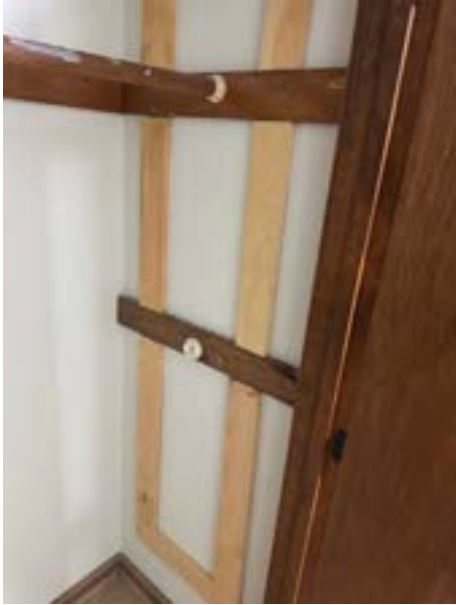
This is the closet that's behind the shower stall that I suggest that that closet gets removed that that room gets turned into an office space and I would make that a hinge door with a handle easily accessible so you don't have to pull out a screw gun to unscrew anything and make that easily viable cause you're paying a plumber to get in there to access it and repair at 100 anywhere from 120 to 150 an hour.

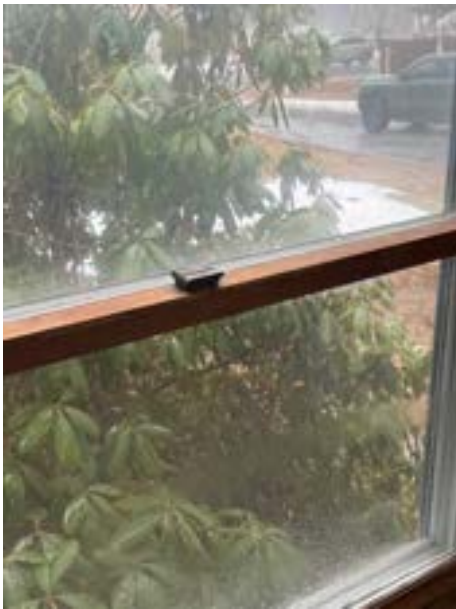
This is the bedroom with the large window. The replacement will need to be customized to fit the current space, you may want to reposition the window and shrink the opening to current standards, or thirdly, frame out and install for two standard size opening vinyl windows.

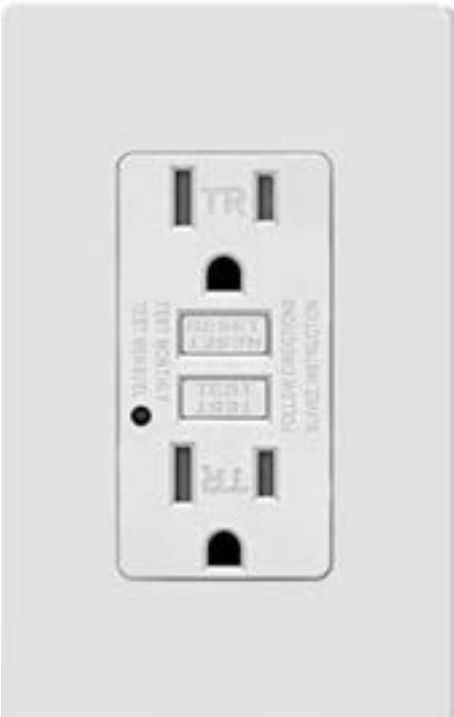
The kitchen had good working grounded receptacles present. However, I would like to see a GFCI on both sides of the water source for added safety.

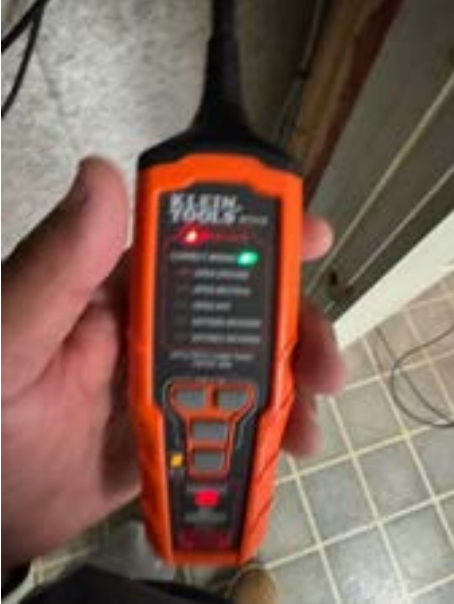
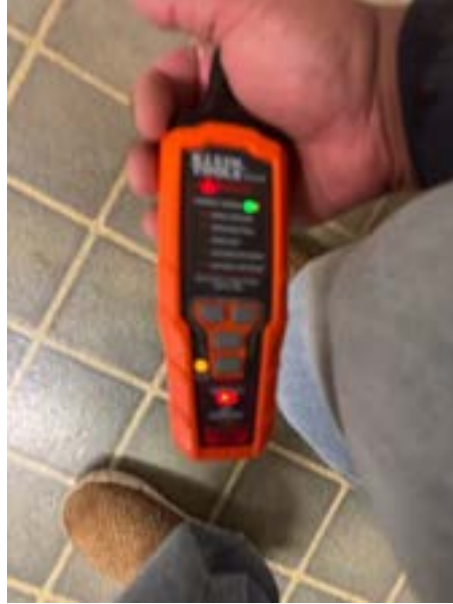
The outlets all tested out correctly with a ground present however, I do recommend that there would be a GFCI (ground fault circuit interrupter) installed next to or attached to the panel right now. It's currently a three prong grounded outlet that's working properly, but it would be nice to have a GFCI in the basement.

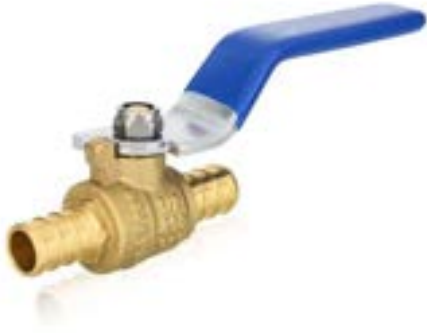
I recommend updating the shut off the main shut off valve handle with the one I have below in the photo.

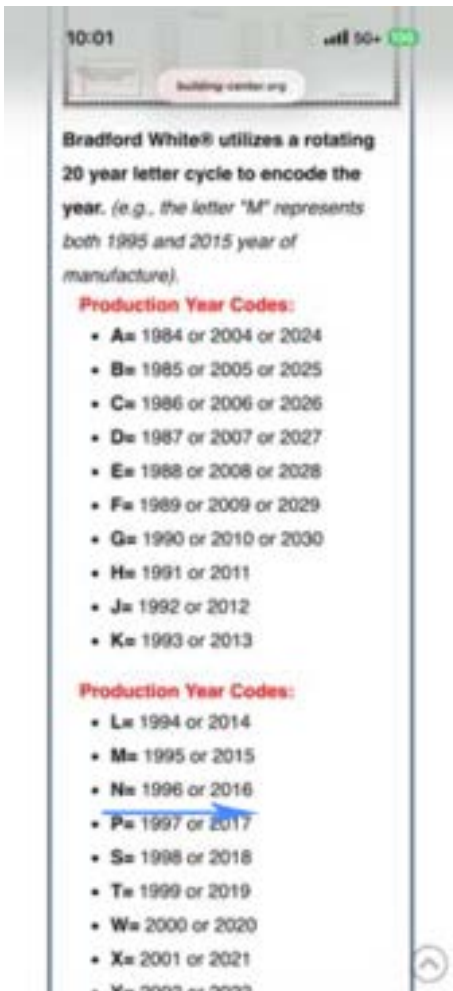
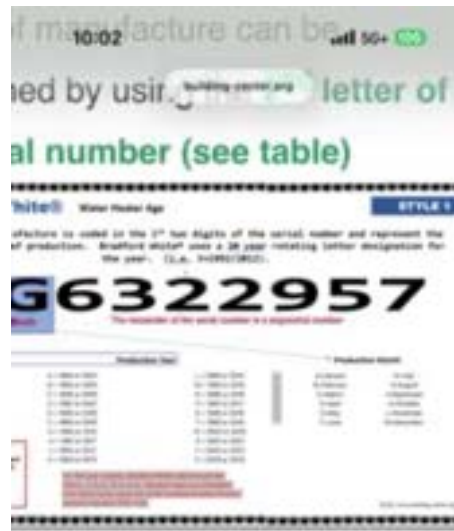
Bradford White Gas Propane Water Heater

Manufactured Date: August 2016 (10 +/- years old)

Water heaters in general have an average estimated useful service life of 10-12 years, though water quality, routine upkeep/maintenance, and location of the water heater will all play critical roles in the longevity of these systems. I recommend consider replacing the water heater and I would install a drain pan to catch any residual water from the TPR Valve (Temperature Pressure Relieve Valve)

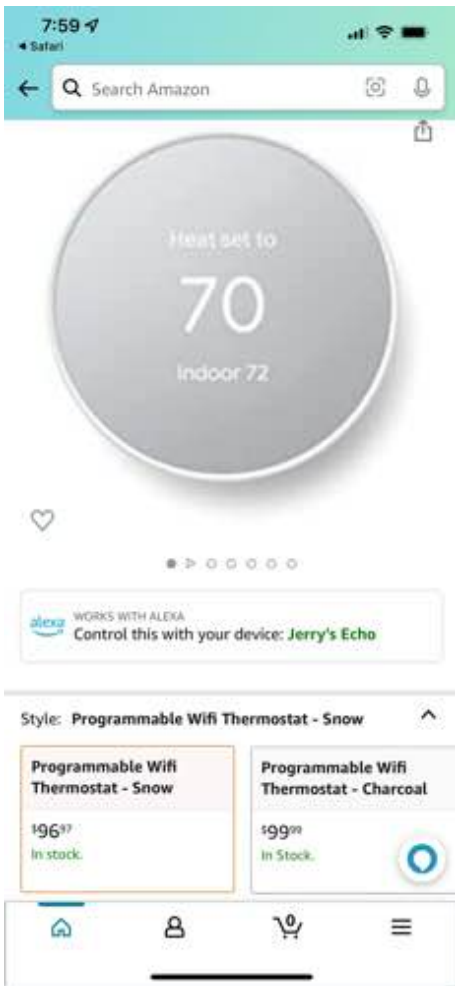
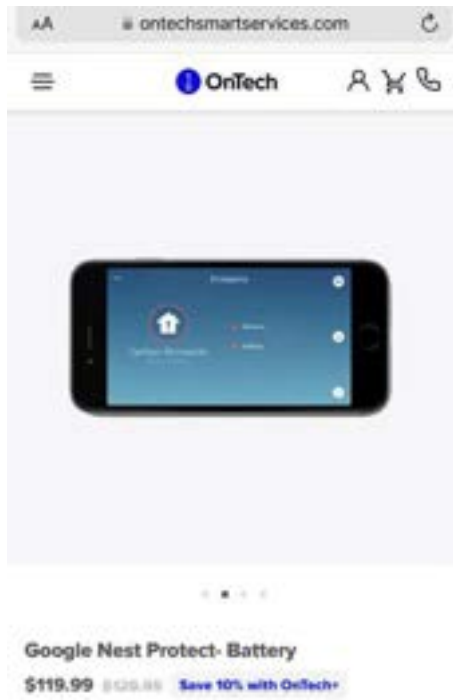
All the thermostats were outdated, but they were all in good working condition. We did have an issue with the one upstairs to the room to the right, but the client was able to figure out how to unlock it and shut it down because it was extremely hot. I recommend updating the thermostats.

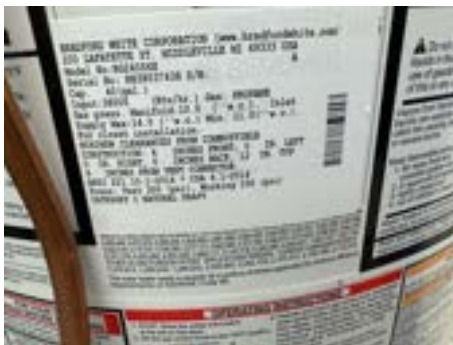
REPLACE THE GAS WATER HEATER Inspected

The current water heater is in good condition, but it is 10 years 10+/- years old. August 2016.

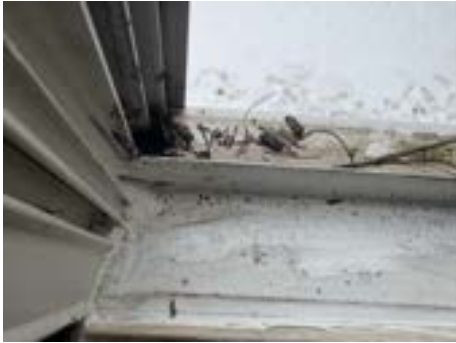
REPLACE UPSTAIRS BEDROOM WINDOW Inspected

I recommend replacing it with a new vinyl replacement window that Seale is they tried to patch it over, but I could still see my fingers through it from the outs from the inside, looking out.

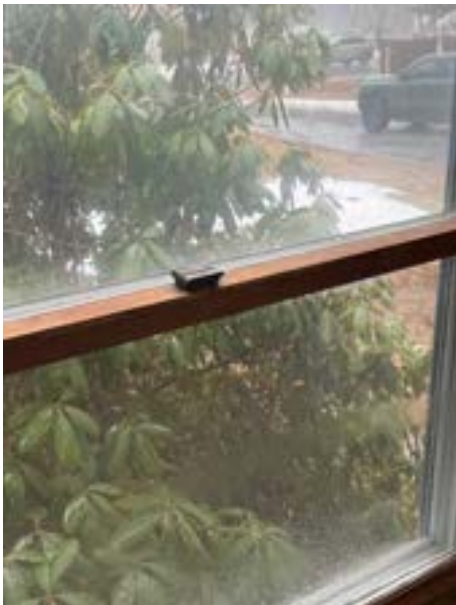
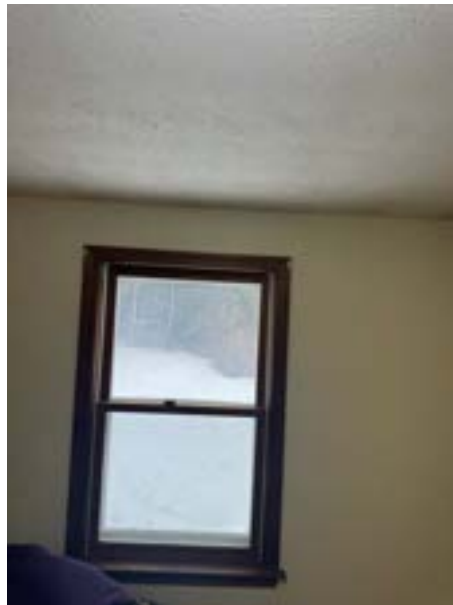
REPLACE ANY BROKE WINDOWS WITH BROKEN SEALS Inspected

I recommend replacing these windows in the bedrooms downstairs both of them look like appeared to have broken seals. I would replace them also with vinyl replacement windows. I would refer to efficiency Maine for rebates also in bedroom four I'd consider what you're gonna do first whether you're gonna shrink the window and make it a standard side standard size opening or turning into two separate windows.

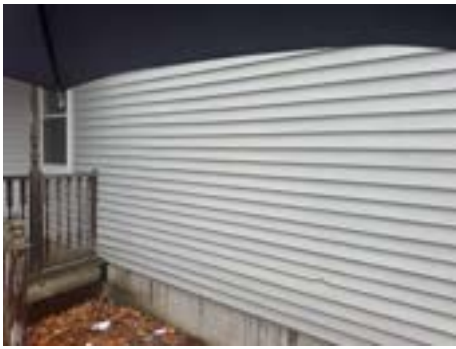
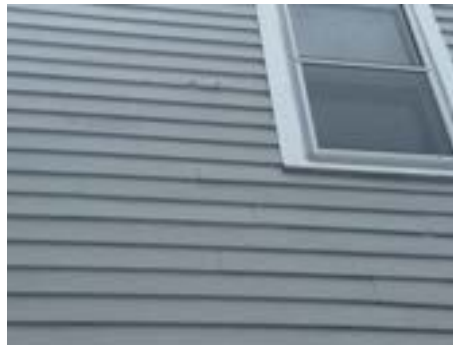
THE PUNCHY WOOD CLAP BOARD EXTERIOR SIDING ON NEAR THE DRIVEWAY SIDE, AND ALSO ON THE FAR SIDE WHERE THERE WAS SOME SORT OF SOMETHING COMING OUT OF THE WOOD OUT OF THE PORES

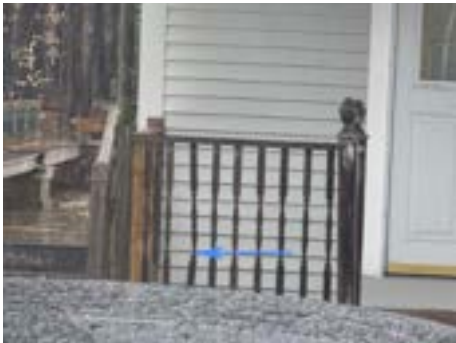
REPLACE BROKEN SPINDLE ON THE DRIVEWAY SIDE PORCH Inspected
Notes:

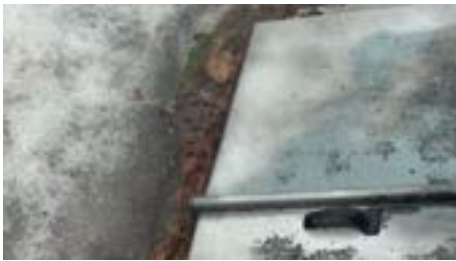
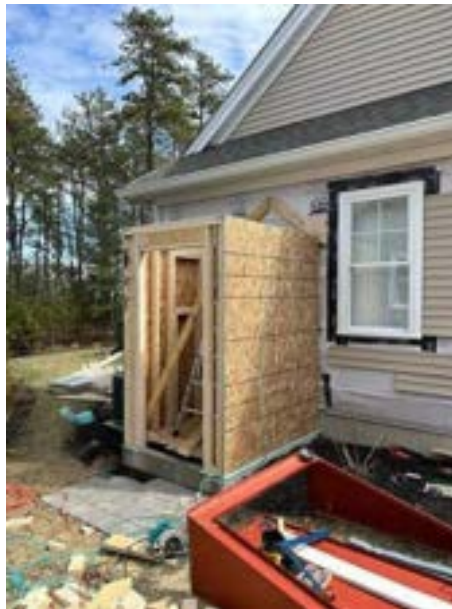
ADDRESS THE BULKHEAD Inspected

In the bulkhead, I recommend adding risers to the steps along with a railing for added support coming up and down the stairs and then lastly I think I would consider turning the bulkhead into a doghouse because it will sit up higher than the ground level. I think what's happening is the bulkhead right into the ground they shoveled out a little spot in front of the bulkhead and the water is just pooling right there so it has nowhere else to go but into the bulkhead there is a I could see daylight because the bulkhead doors weren't shut and if they're not shut firm, then it's there's going to be an opening for potential water infiltration.

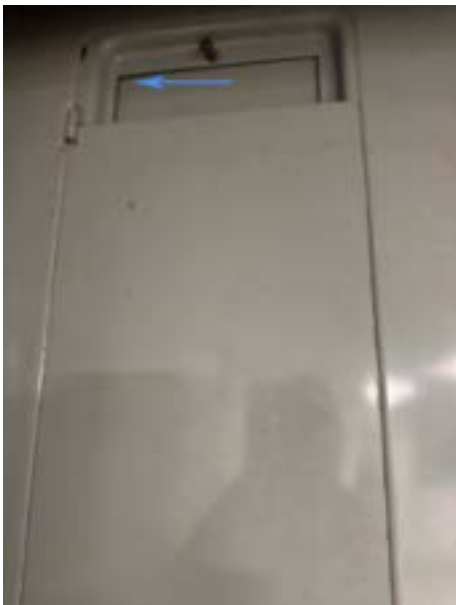
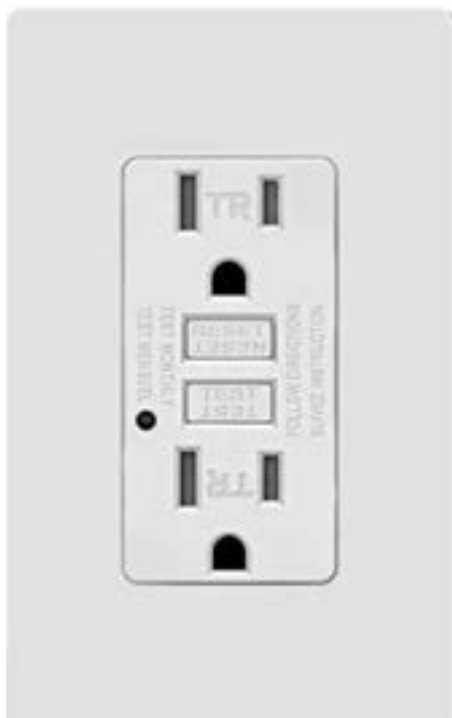
I RECOMMEND EITHER MOVING THE ELECTRICAL PANEL DOWN AND INSTALLING A NEW ELECTRICAL PANEL DOOR BECAUSE THEY CURRENT ONE IS CUT TO FIT THE SPACE

I recommend bringing it down from the top of the door door opening install installing a new electrical panel door and I would suggest installing a new GFCI in and replace the three prong grounded outlet. That's attached to the electrical panel for add a piece of mine.
