OnPoint Home Inspections Service

March 16th 2026, 10:00 am

INSPECTION DESCRIPTION: General Home Inspection plus Air Radon

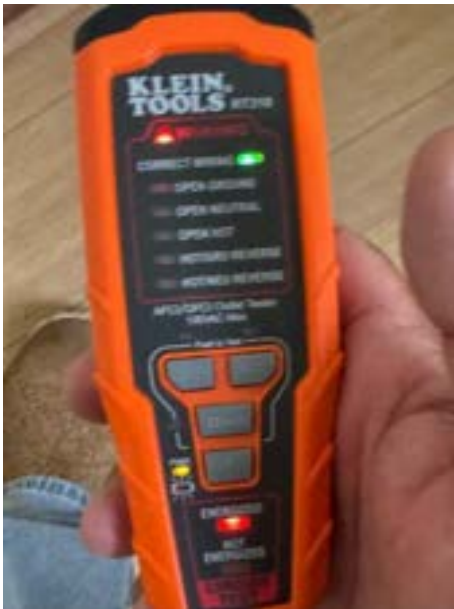
The outlets were tested and they tested out correctly with a ground present.

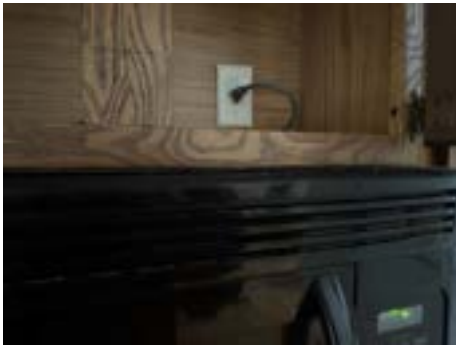
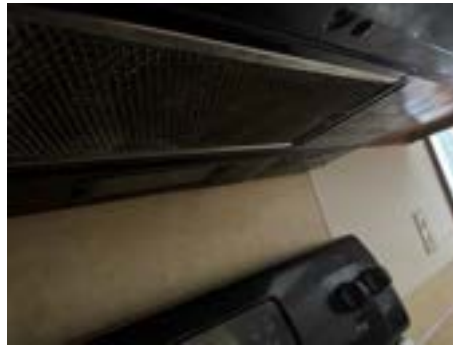
There's currently no exhaust hood. There is however, an overhead microwave with a recirculating fan with multiple speed function's It also has a light function which wasn't working at the time of my inspection. I recommend just replacing the bulbs on the light function. I think that you should be fine. In addition, it would be a good idea to find out if the direct vent is actually exhausting the stove. We were unable to determine whether it was more for show or it was fully operable.

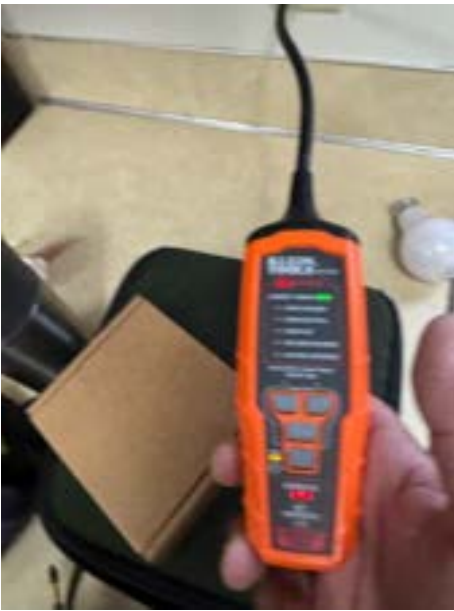
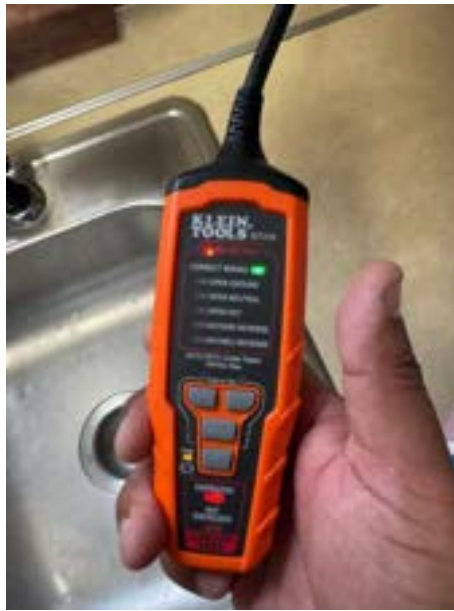
The kitchen had good working grounded receptacles present. However, I would like to see a GFCI on both sides of the water source for added safety.

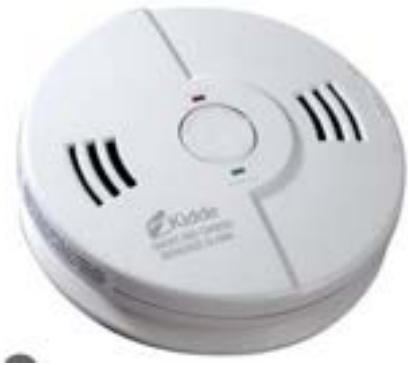
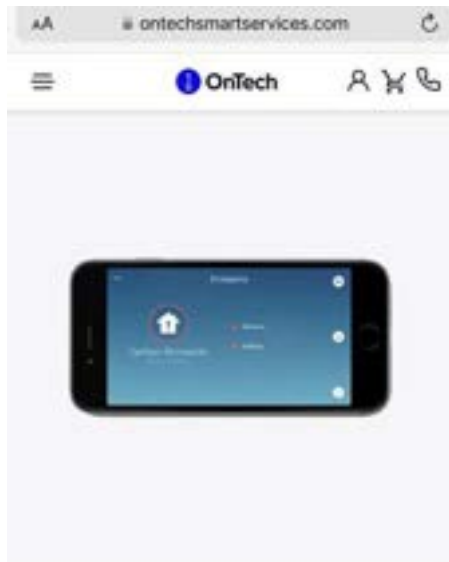
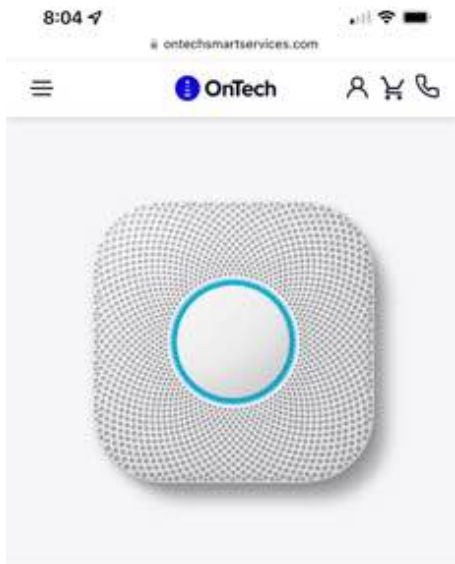
I recommend adding new CEO smokes throughout. You have an option of getting them hardwired which I always suggest is the best but a lot of people use the alternative of the Bluetooth interconnected battery Google nest. The first photo below is the hardwired CO smoke combo. The second one is the Google nest, which is controlled by your smart phone where you can Be alerted when you're not at the house and you can reset the system.

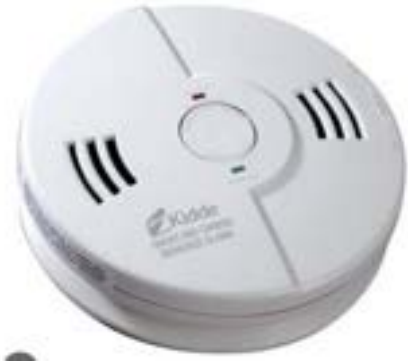
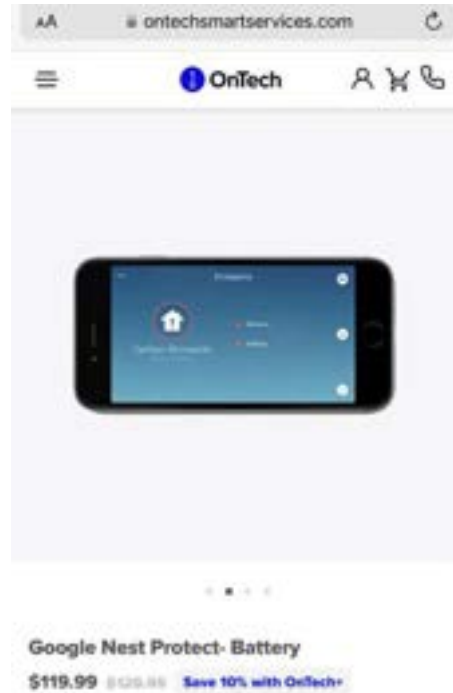
On average the CEO smokes last for about seven years. You may be able to get away with doing one in the lower hallway and one in the upper hallway due to the common area proximity to the two bedroom's. That's something you would want to ask a licensed electrician to see that it meets updated code requirements. That may save you some extra money you may not have to do them in the individual bedrooms as well.
